Rebuild ready: 3D mapping of a quake-damaged cathedral

After the cathedral of Christchurch, New Zealand, was hit by an earthquake, drones and advanced photogrammetry software supported the rebuilding work.

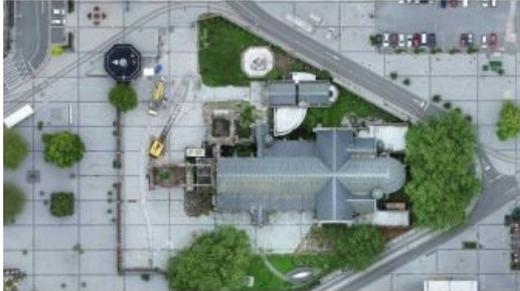
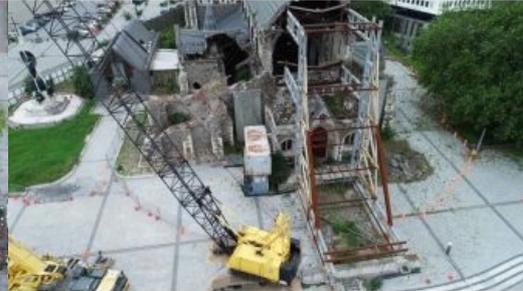
Surveying a damaged building can be dangerous. Mapping, using drones, reduces risk to staff and costs to the community. This case study of the iconic cathedral of Christchurch, severely hit by an earthquake, demonstrates how drones and advanced photogrammetry software delivered the orthomosaic map, enabling the accurate spatial planning needed to rebuild the cathedral.

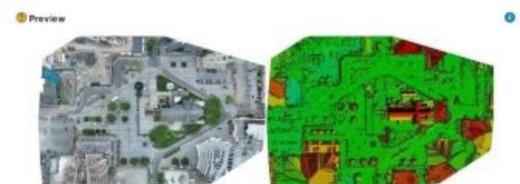
2D orthomosaic of the Christchurch Cathedral in Pix4Dmapper.

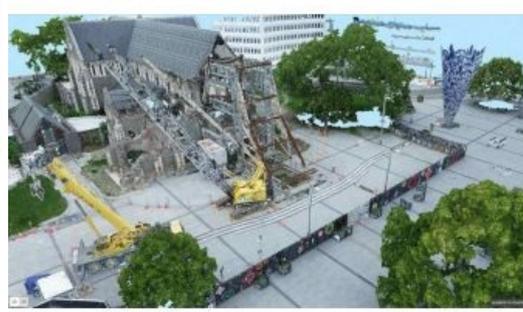
The drone flight captured the damaged Cathedral.
